‘Grout First,’ Right Answer for Sullivan’s Island, S.C.

By Don Rigby

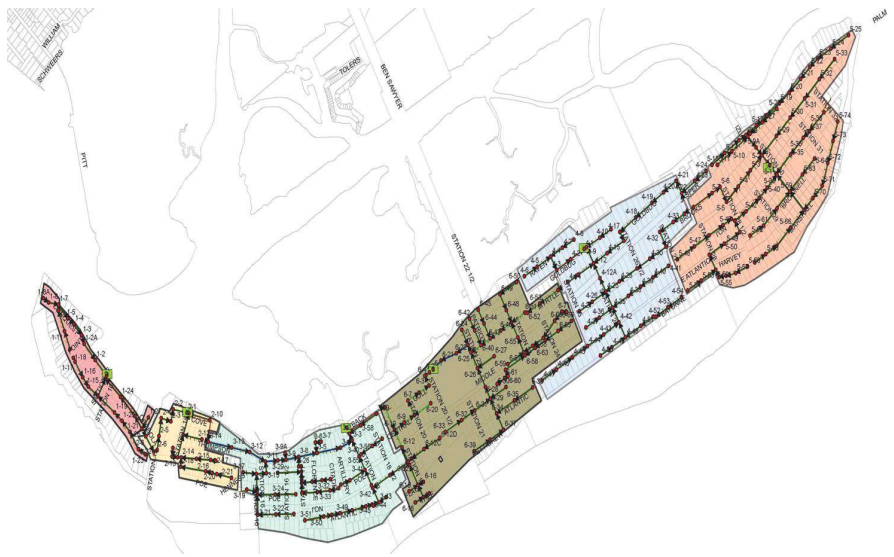
Sullivan's Island is divided into six basins, from left, 1, 2, 3, 6, 4 and 5. Phase 1 of the project focused on the high priority basins — 5 and 6 — and Phase 2 is set to begin in October 2016 and will focus on Basin 3.

Phase 1 of the project focused on high-priority basins 5 and 6. A total of 38,000 ft of mainlines and the first 7 ft of the laterals and lateral connections were sealed with injection grout in order to control infiltration. Additionally, 1,900 ft of mainline was CIPL lined and eight cured-in-place pipe (CIPP) point repairs due to structural defects.

Phase 2 is now set to begin in October 2016 focused on Basin 3 for mainlines and lateral connections, but this time, the length of lateral sealing will extend to the property right of way versus the first few feet from the mainline.

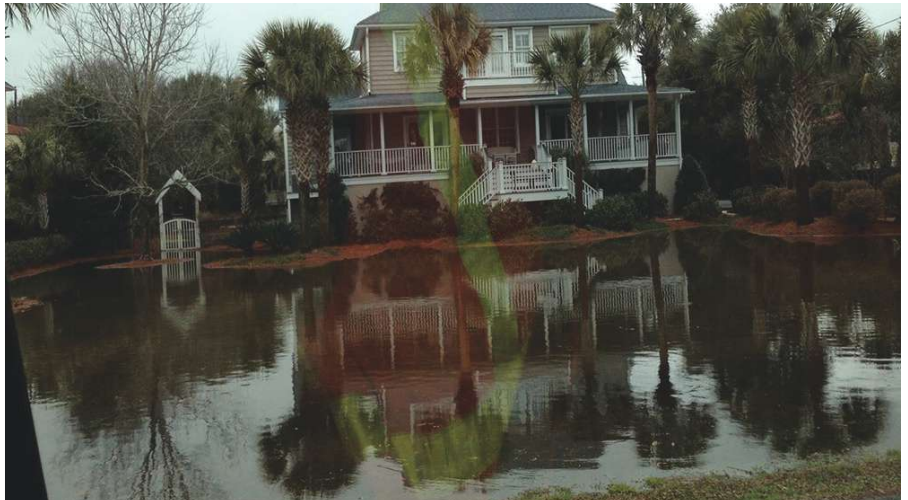
Sealing the collection system provided a bittersweet result: standing water after a rain. Previously, stormwater runoff was aided by the porous sanitary system, which swept away surface and groundwater to the wastewater treatment plant at high-expense to the ratepayer.

come to visit the historic attractions. Rain events today now have new meaning. Previously, stormwater runoff was aided by the porous sanitary system, which swept away surface and groundwater to the wastewater treatment plant at high-expense to the ratepayer. Now, standing water after a rain event

is visible proof-positive of a sealed collection system. Stormwater management is the responsibility of Charleston County and Gress is working with those authorities on a study to resolve this new bittersweet issue for island residents and visitors.
