**USL StructureCare**  
Kingston House  
3 Walton Road  
Pattinson North  
Washington  
Tyne & Wear  
NE38 8QA  
United Kingdom

**intu Merry Hill**  
West Midlands  
DY5 1QX

## Structural Motivations

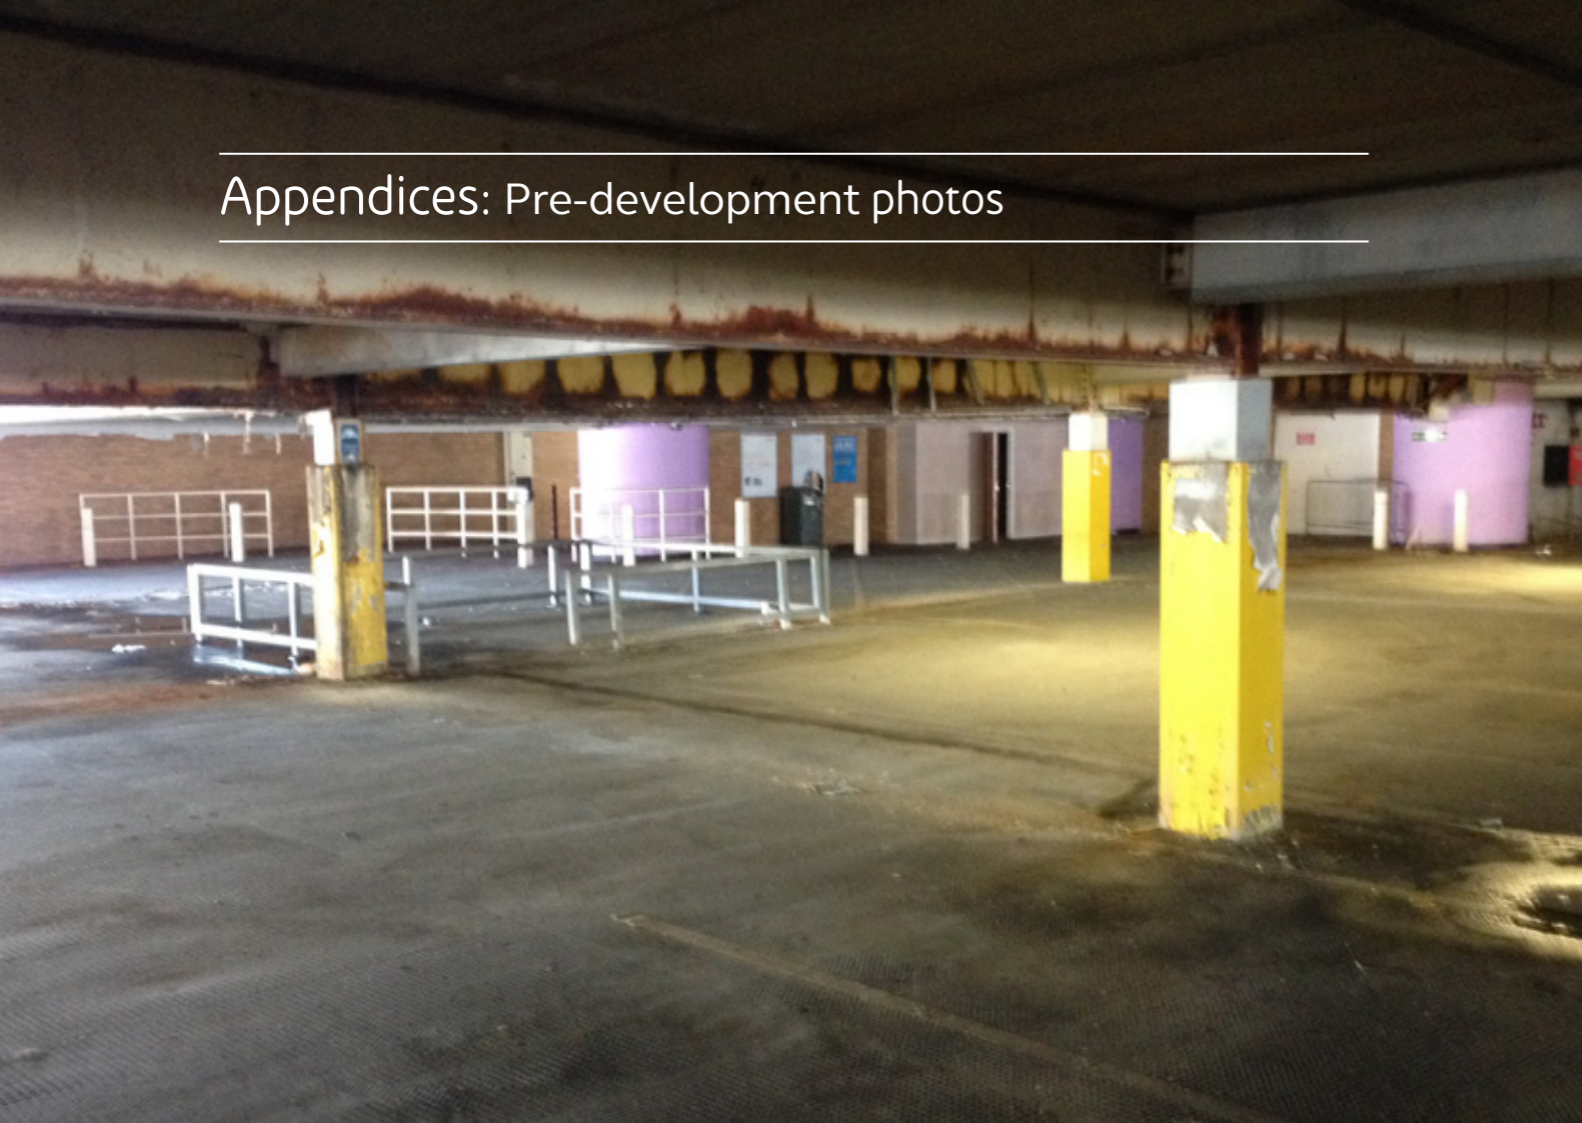
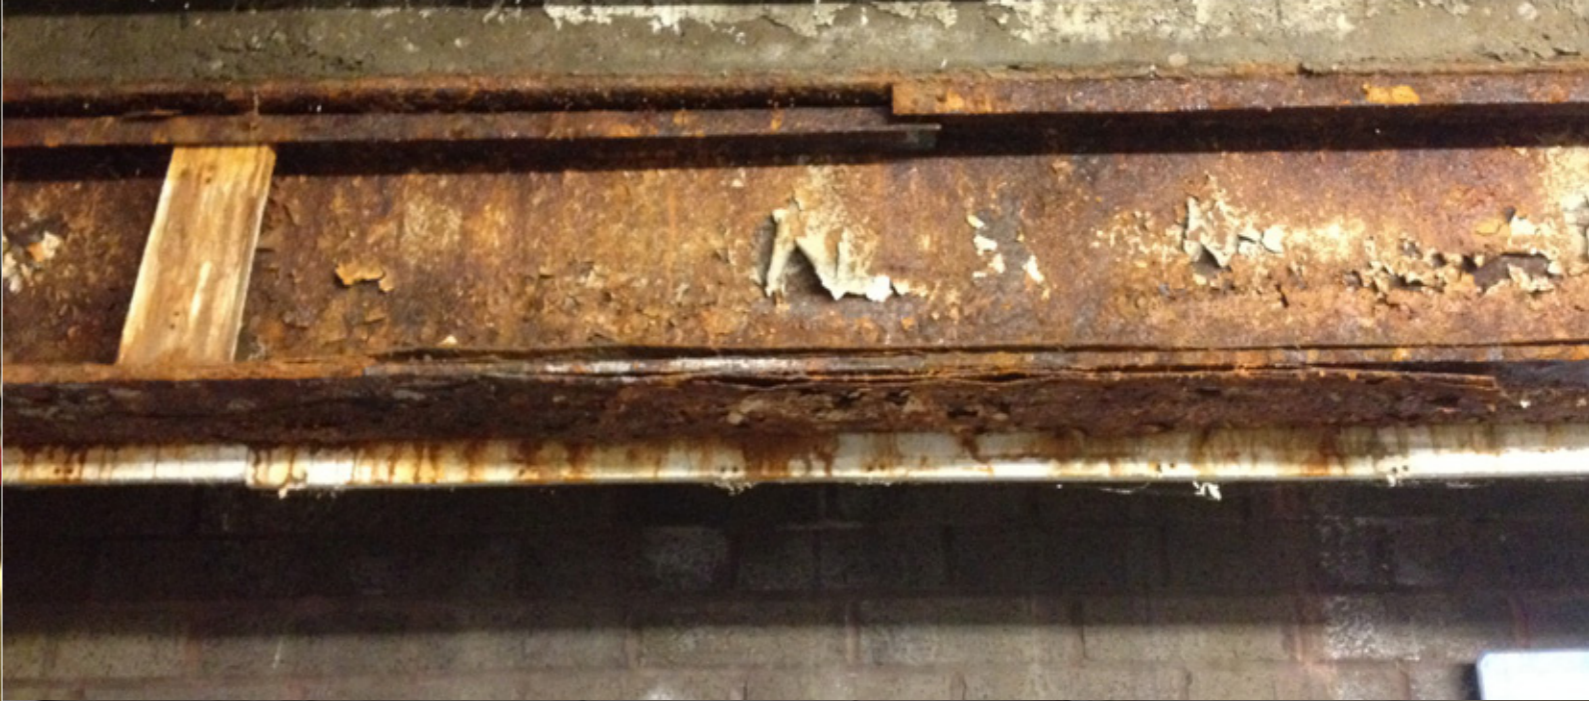
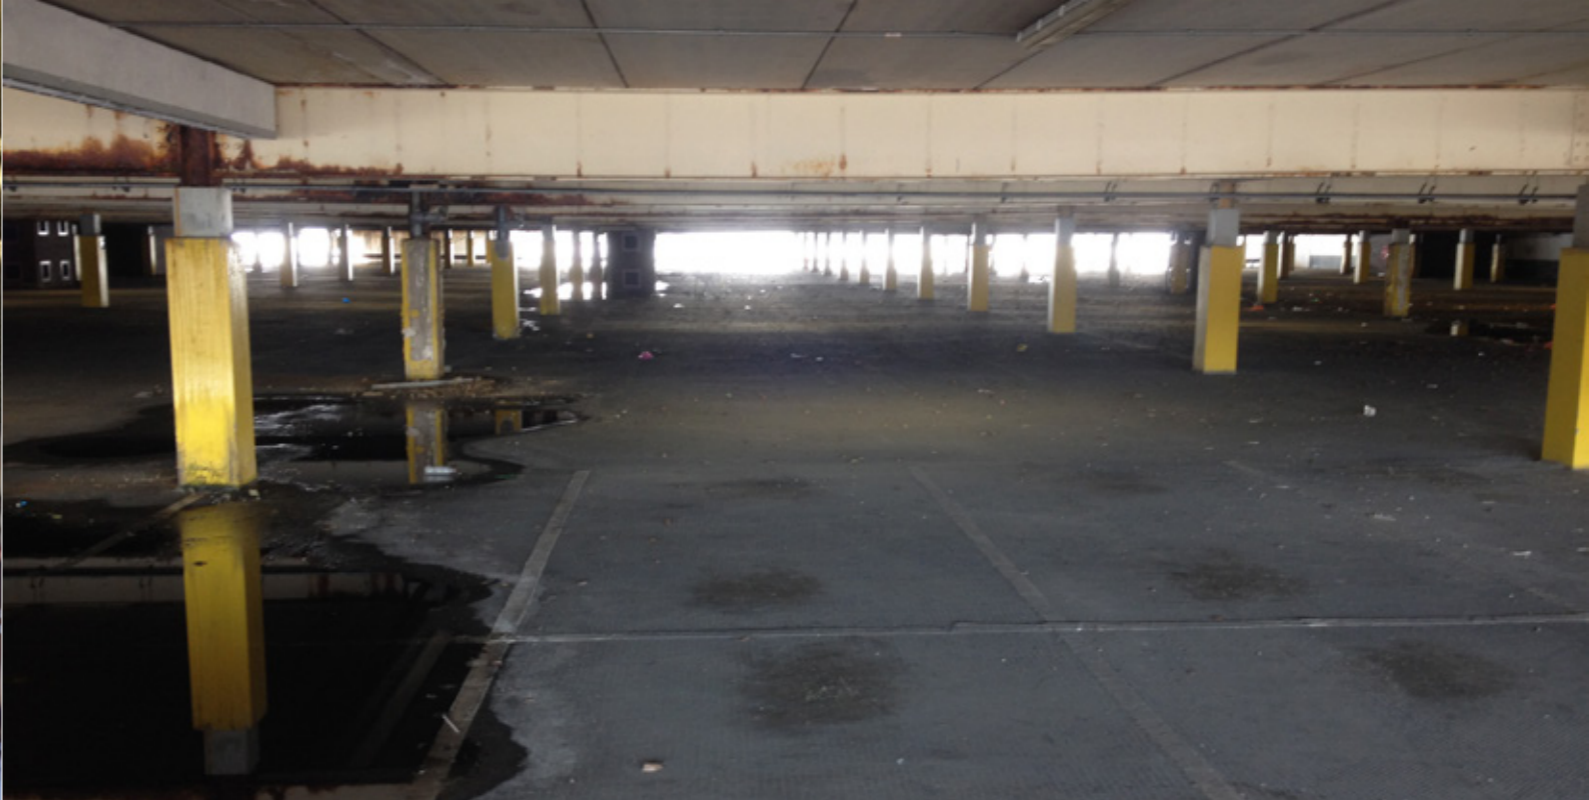
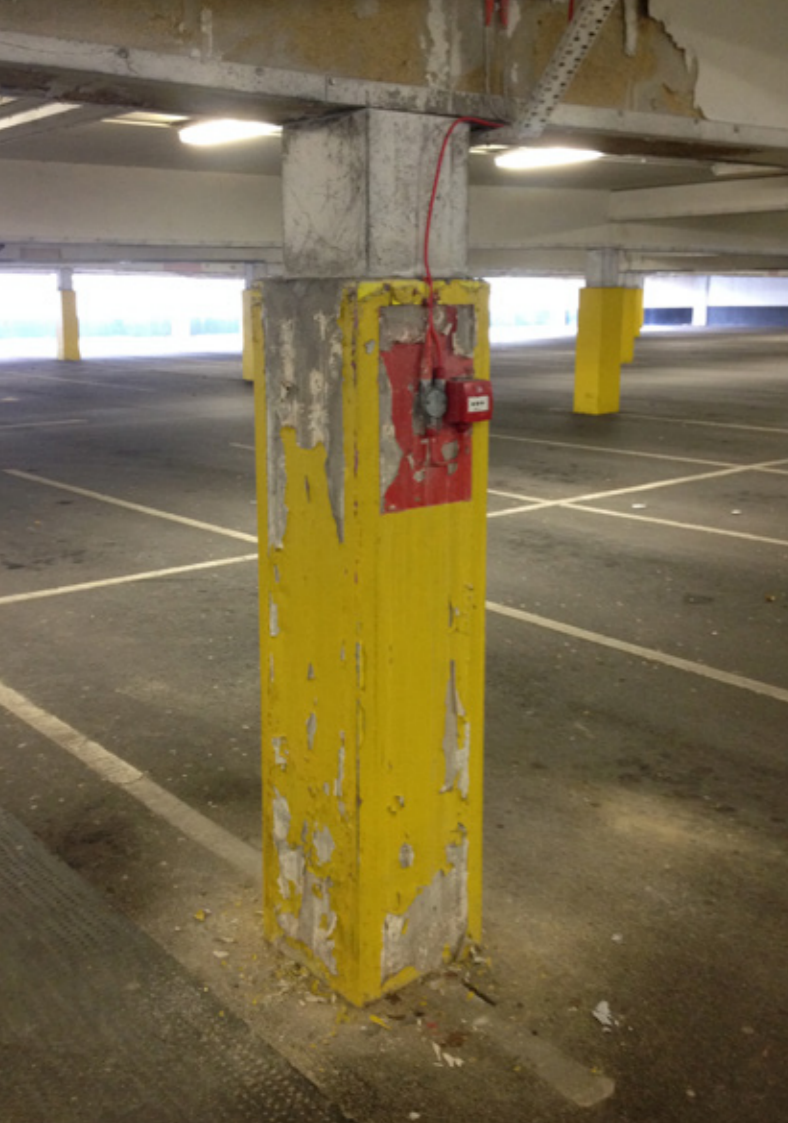
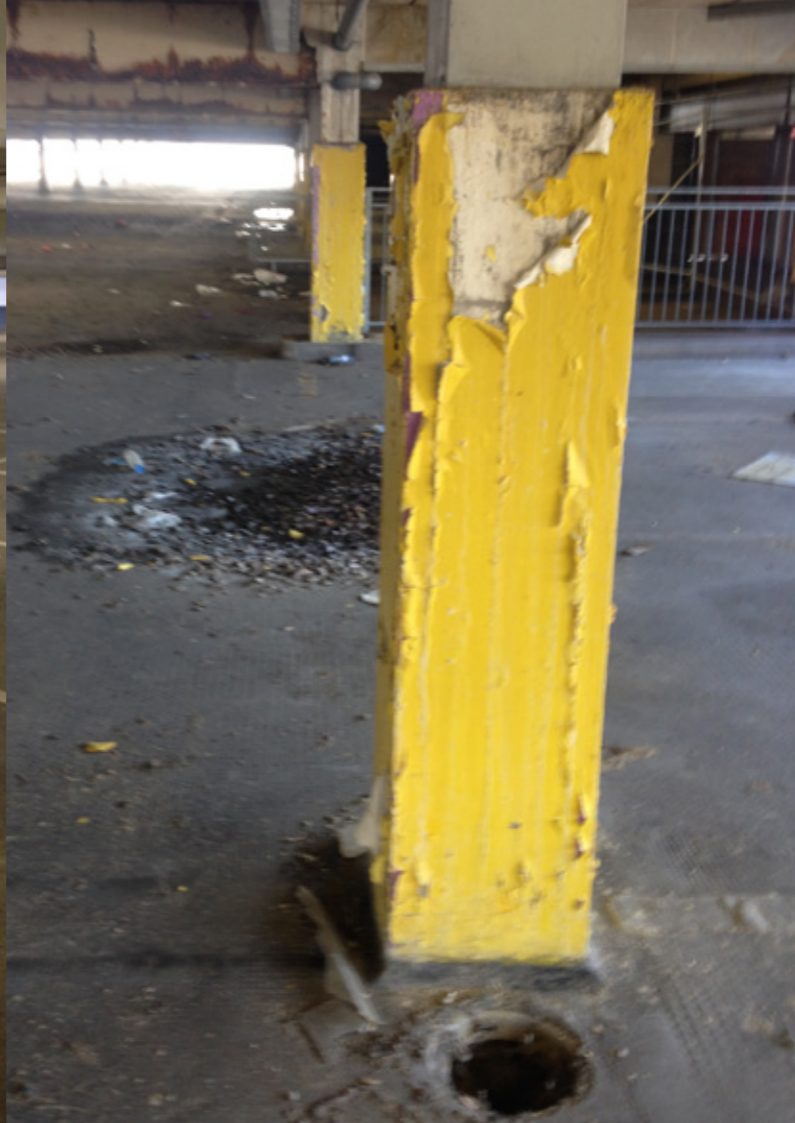
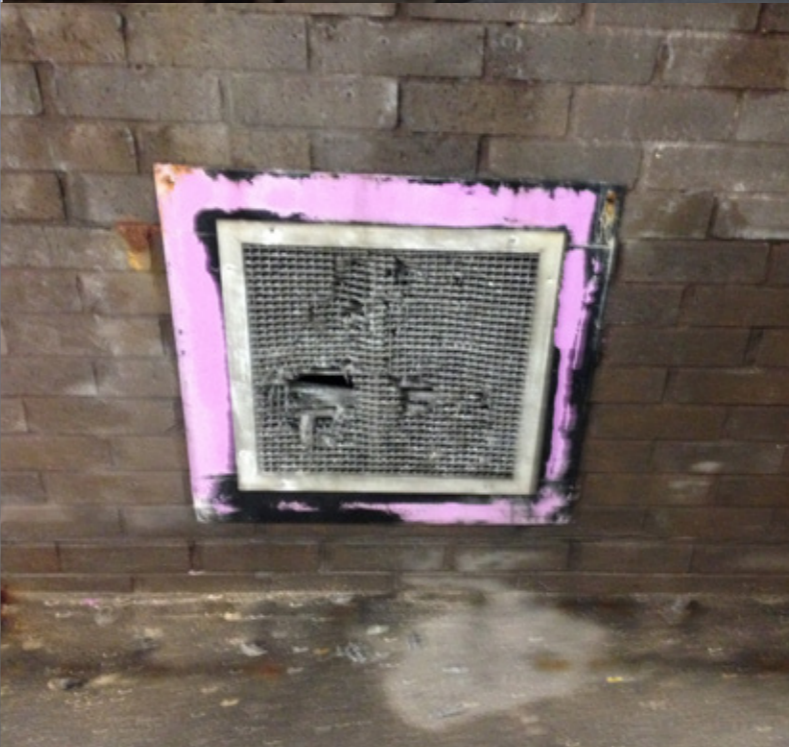
Appendices: Pre-development photos

The refurbishment of the Purple Car Park became necessary following the discovery that some of the car park's steel support beams, soffits and columns had become severely corroded over time from water ingress from the upper (top) deck. The corrosion had also had an impact on the applied fire protection to the car park's structure. In some areas, there was no existing fire protection at all as the fire boarding had crumbled as a result of water ingress. There was significant deterioration of the mastic asphalt wearing surface on the upper deck.

It was determined that the mastic asphalt wearing surface to level 3 would be replaced like-for-like, so a new mastic asphalt wearing surface was installed. The steel frame on the lower levels was blasted using a quill-blast technique to remove existing paint. A high-performance intumescent paint was then sprayed to all areas and finished with a decorative layer of white paint. The lower decks of the car park, originally surfaced with a combination of mastic asphalt and macadam, were overlaid with a high performance system incorporating a fast-curing polyaspartic top coat, so that the car park could be returned to service quickly on completion of the works.
